Masonry renovation "Michael" bastion on the Petersberg

Company	PORR Spezialtiefbau
Type	Rehabilitation
Runtime	07.2014 - 10.2014
Principal	Stadtverwaltung Erfurt

Static securing of a retaining wall using soil nailing

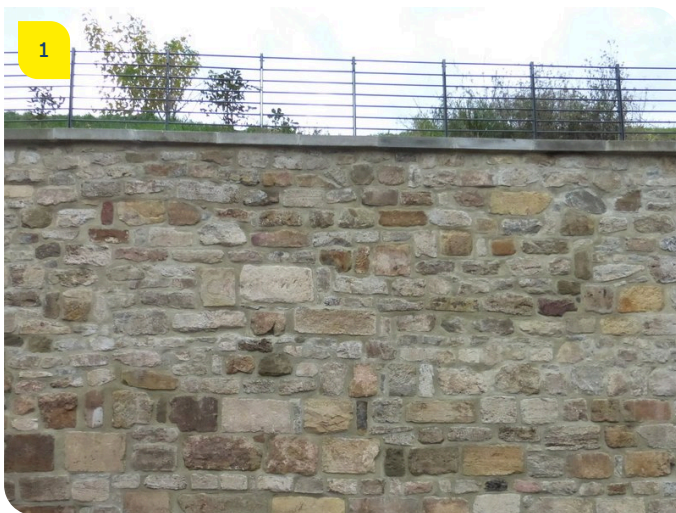
1

Masonry renovation of the "Michael" bastion on the Petersburg

The renovated retaining wall.

The two pieces of the wall that had broken out first had to be cleared in order to then permanently secure the pressing slope with the help of boreholes and grouted piles. Finally, both excavations were faced with natural stone masonry and filled by injection. The section of wall with the bulge was also secured with grouted piles to permanently prevent further excavation. Concrete pockets were cut out so that the piles were no longer visible at the end. The same procedure, only with a larger drilling diameter, was used for the support pillars. Here too, the cavities behind the wall were filled by injection. In addition, the neighbouring masonry and the masonry crown in this area had become unstable due to partially broken joints. These allowed water to penetrate and the stones to weather or loosen.
