Rehabilitation of the historic dam wall, Kerspe dam

Data and facts

Company	PORR Spezialtiefbau GmbH
Type	Rehabilitation
Runtime	03.2021 - 05.2022
Principal	Wupperverband

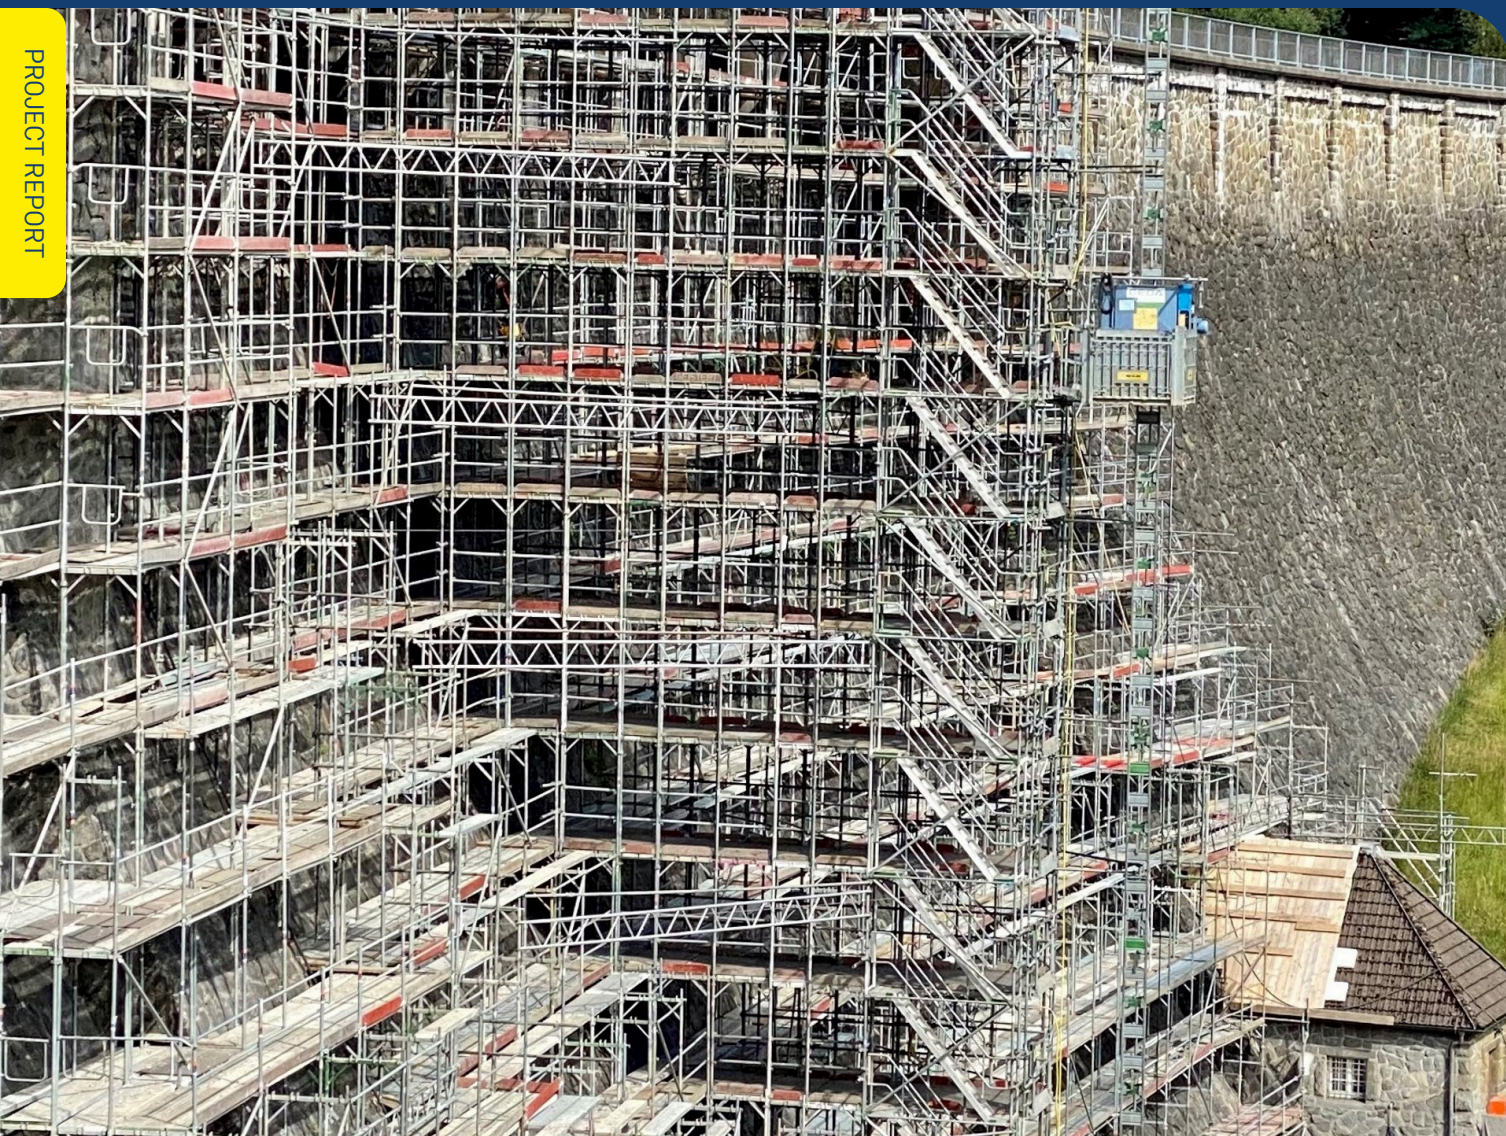
PORR special civil engineering was deployed at the Kerspe dam for the rehabilitation and cleaning of the approx. 2,800 m² listed dam wall as well as the bottom of the stilling basin.

For the rehabilitation, the damaged joints were rinsed out using high-pressure water jets, around 5,000 damaged stones were replaced with new stones and the masonry was finally spray-pointed.

The bottom of the stilling basin was also originally built with quarry stones. Drill core analyses revealed masonry damage down to a depth of 50 cm. The masonry was therefore dismantled and the base rebuilt with 450 m² of reinforced concrete.

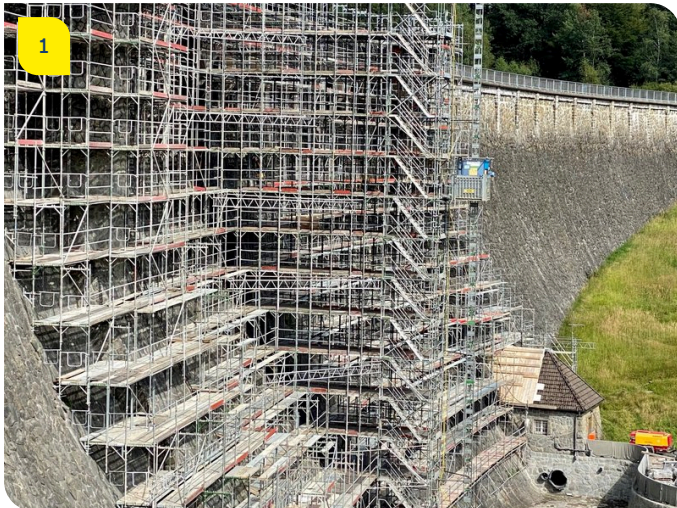
1

Rehabilitation of the historic dam wall, Kerspe dam
