and the Horster Dreieck A7, Seevetal-Ramelsloh junction

Company	PORR Verkehrswegebau GmbH
Type	Highway
Runtime	05.2024 - 05.2024
Principal	Autobahn GmbH des Bundes

Frostschäden auf der A7: Erfolgreiche Sanierung an einem Wochenende

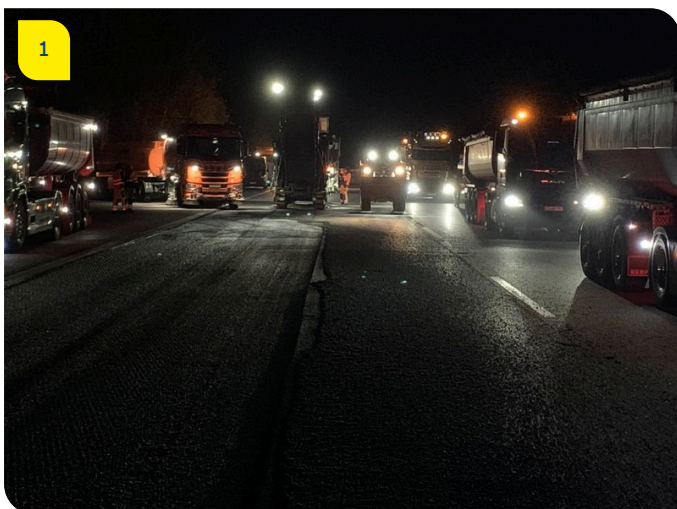
1

In order to minimise the impact on traffic, all the work was carried out in a 24-hour operation over just one weekend.
