Tunnel trough repair, Mönkedamm, Hamburg

Company	PORR Spezialtiefbau GmbH
Туре	Retrofitting foundations, Rehabilitation
Runtime	06.2021 - 07.2021
Principal	Fr. Holst GmbH & Co. KG

105 micropiles replace oaken piles dating back to the 1920s

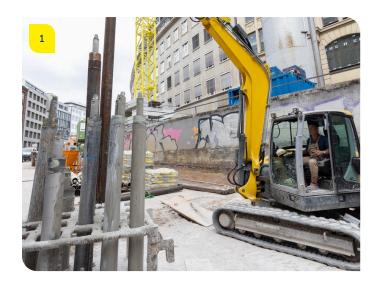
1

The micropiles were installed in the tunnel exit.
